# Learning Event

## Dropped Object

A 30 kg piping support was found in a gas plant pipe rack. It had fallen approximately 2m to the pipe rack, which is 6m above a pedestrian traffic area.

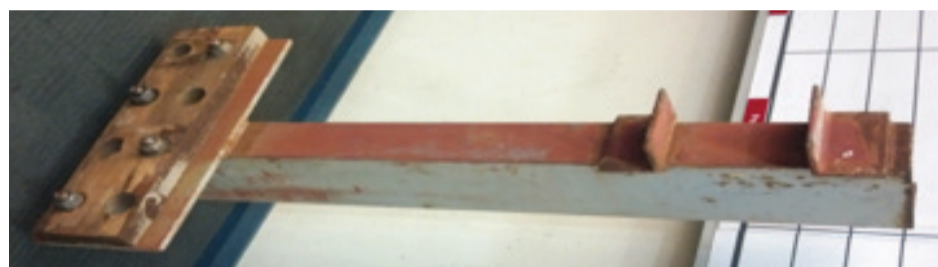
Pipe support with Permal block

- > Survey and identify any piping supports with Permal blocks installed in tension. Implement a strategy to manage the immediate and longer term risk.
- > Update pipe support design documents to identify and propose strategies to mitigate the risks associated with Permal pipe support failures.

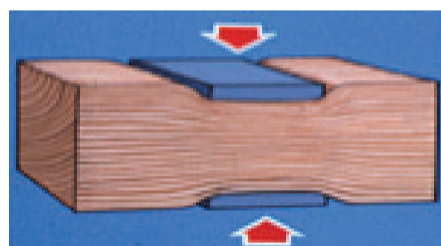
Permal in compression

It is possible for deterioration of aged Permal blocks to result in failure in compression.

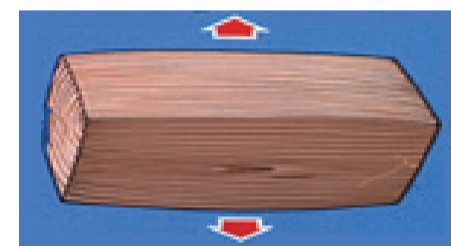
Permal in tension

The condition of the Permal block, which supported a load in tension, had deteriorated over time. The block failed by splitting into two pieces. It is believed that the final fracture was initiated by a single load event, possibly operational draining activities.
